PERIODIC INSPECTION OF PC BRIDGE WITH BOTH ROBOT TECHNOLOGIES AND CLOSE VISUAL OBSERVATION

K. Rokugo¹, H. Hatano², and Y. Mizobe³

The Guideline for Periodic Road Bridge Inspection was revised in February 2019 so that new inspection technology could be used in Japan. Gifu University SIP research team adopted robot technology (RT) for the mandated periodic inspection of Kakamigahara Bridge in Gifu, Japan, before the revision of the Guideline. Based on the guidelines (draft) proposed by a committee of our team, two-step inspections were adopted. In the first step, "preliminary survey" was carried out by using RT. In the second step, "close visual inspection" was conducted on the entire bridge by inspectors using the results of the preliminary survey. The preliminary survey utilizing RT enabled the inspectors to ascertain and inventory the types and locations of defects, thereby allowing them to narrow down the locations and segments where intensive close visual observation is required. As a result, the number of days required for close visual inspection using an ultra-large inspection vehicle on Kakamigahara Bridge was significantly reduced to 4, which would otherwise have been 10 b

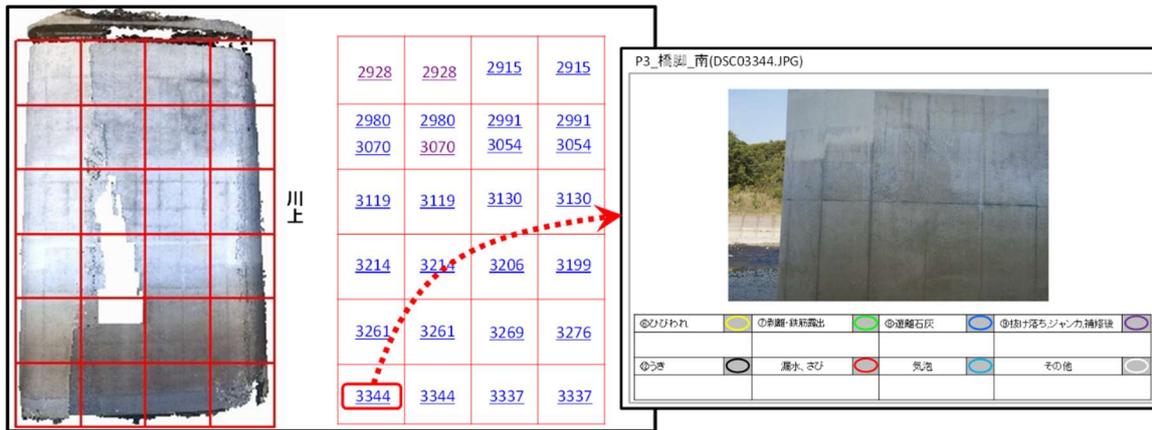
Figure 6. Result example of wide area survey.

As to the results of the wide area survey, the orthophotograph of each structural unit (a span in the superstructure and a pier in the substructure) was divided into a 5m by 5m mesh as shown in Figure 6, with each mesh unit being connected to original photographic images. Defect marking, note entering, and image expansion can be done on the original photographic images. This significantly facilitated confirmation of defects and preparation of materials for planning subsequent close visual inspection.

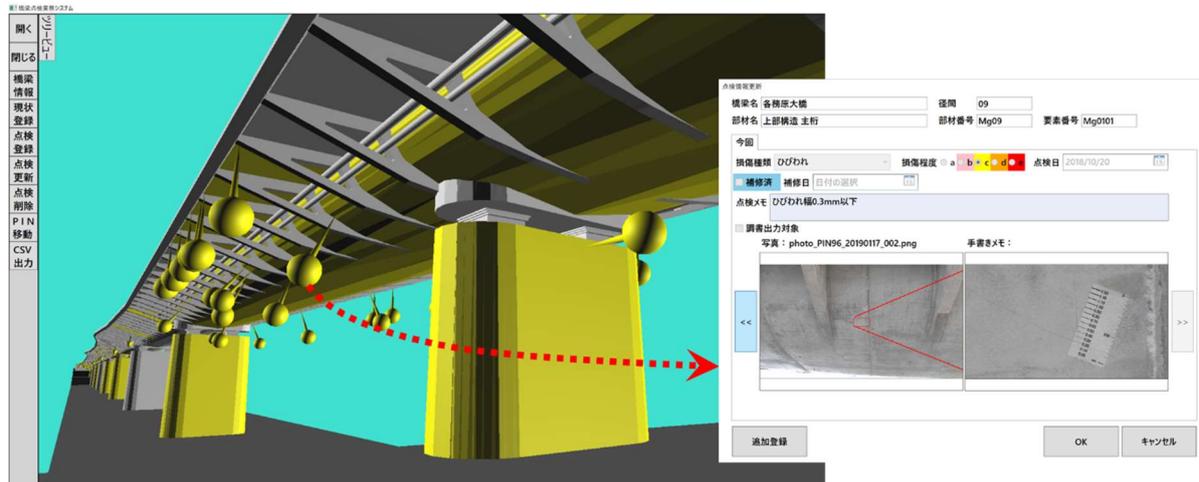
Figure 7. Result example of narrow area survey.

The results of the narrow area survey were inventoried into defect maps and photo files for reference when organizing close visual inspection. The defect maps were laid out on the background of the orthophotographs created based on the wide area survey to facilitate understanding of the positional relations between defects and the structure. Furthermore, 3D structural models were displayed on a tablet device as shown in Figure 7 to show the location of each defect detected. This was also linked to its photograph, along with the soundness judgment, to be available at the site of close visual inspection for enhancing the work efficiency.
