Clarification of Performance Requirements for Utilizing Robotic Technology for Regular Inspection of Steel Bridges

R. Hasuike

Department of Civil Engineering, Gifu University, Gifu, Japan

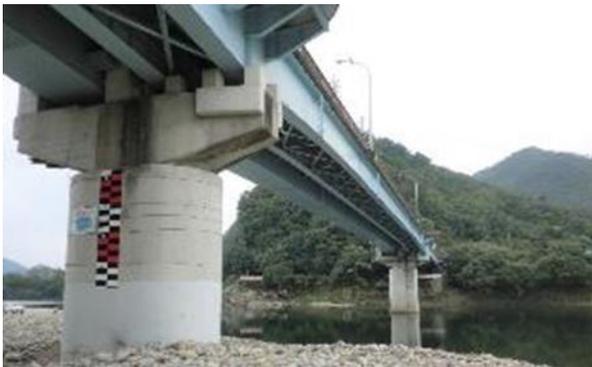
Figure 1. Chidori bridge.

Figure 1 shows Chidori Bridge which is a 3-span steel girder bridge with a spanning 215.5 m over Nagara River. This bridge had been used from 1969 as a bridge for vehicles such as cars. In 1988, the steel box girder bridge, which is for the path of vehicles, was constructed on the upstream side, and the utilization of previous girder bridge was changed for a pedestrian/bicycle path. This previous girder bridge has a narrow space as shown in Figure 2 because of a lot of attachments. It makes the

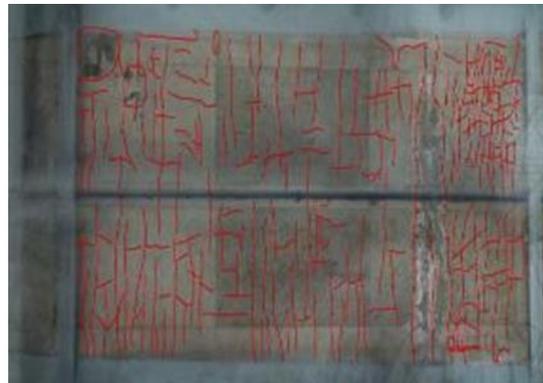
Figure 4. Created crack damages map.

The UAV type technology which has a passive rotating spherical shell and the outside diameter is 96cm (Table 3 (A)) was selected in this field. This technology enables stable flight even when touching a member by attaching a passive rotating spherical shell. This function allows taking images by a close distance which is up to approximately 50 cm to the inspection object. According to the results from this field testing, it was possible to take images from a close distance to the inspection object even if there was some attachments as shown in Figure 3. In addition, as shown in Figure 4, the damage map can be created from the obtained data. The map was created by the following steps: detecting the

damages such as cracks, mapping it, then processing the images to a panorama. From those results, the possibility of taking photography from a close distance in a narrow space by this technology was confirmed.

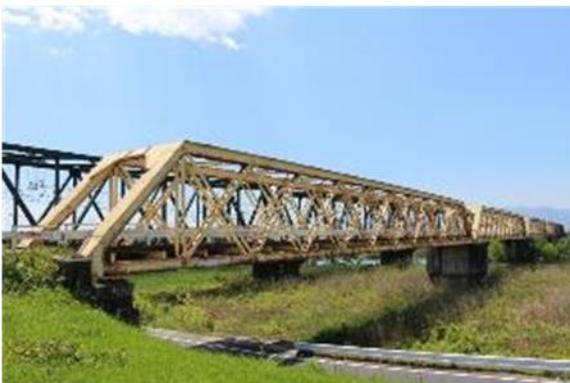
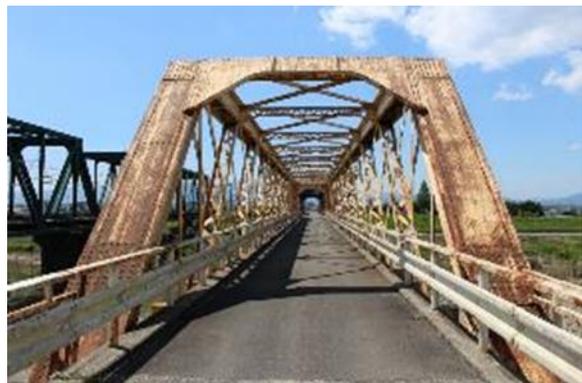
Figure 5. Ibigawa bridge.

Figure 5 shows Ibigawa Bridge which is a 5-span steel truss bridge with spanning 325.1 m over Ibi River. This bridge was constructed as a railway bridge in 1886, and the material is a wrought iron from British. From 2000, this bridge has been used as a pedestrian/bicycle path. In addition, in 2008, it was recognized as one of the important cultural properties in Japan, because it was constructed as an

important large-scale railway bridge and the state-of-the-art techniques in the Meiji period (1868 to 1912) were used to construct it. Therefore, not only management as a road structure but also management as an important cultural property is required. In other words, there are many maintenance limitations such as restrictions on the installation of scaffolds during bridge inspections and using the same materials (wrought iron) as when it was constructed for repair work such as corroded members. From those limitations, the inspection costs will become higher than common bridges.

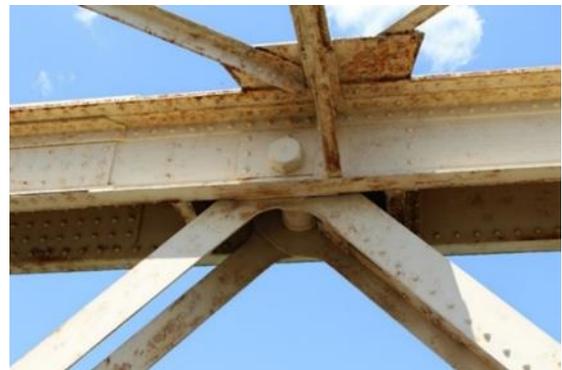
Figure 7. Panel point of truss bridge.

images of the complicated structure such as the panel point as shown in Figure 7. The “Camera system for bridge inspection” was set up on the bridge surface as well. The arm with the high-resolution camera was moved along the bridge, and the arm and the camera were inserted into the gap between the diagonal members. By this technology, the images as shown in Figure 8 were obtained, and the deformation of the lower surface of the bridge can be detected. When considering using such an arm-type technology in a truss bridge, to reduce the work-time to insert the arm between the diagonal members is one of the important points to conduct an efficient inspection. In this field testing, the time from positioning on the bridge surface to completion of arm insertion under the girder was about 5 minutes, and the arm movement between the truss panels was about 12 minutes. It was thought that the work efficiency was good enough. Next, about (II) Detection of deformation such as corrosion and cracks in coating and (III) Detection of falling off bolts and rivets etc., were confirmed. In both technologies, it is possible to detect the defects such as corrosion, coating cracking and delaminated coating etc. as shown in Figure 6 and Figure 8. In addition, by using the zoom up function as shown in Figure 6 (b) and Figure 8 (b), a narrow area’s corrosion such as corroded rivets can be detected

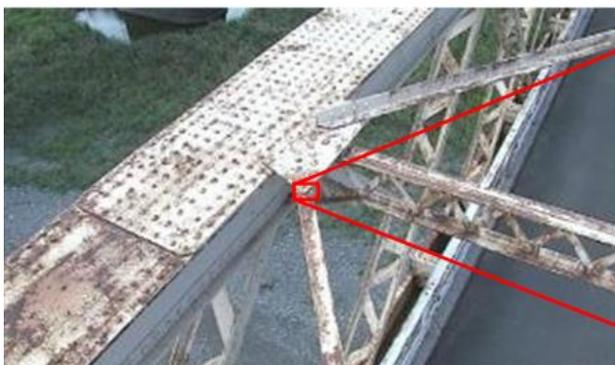
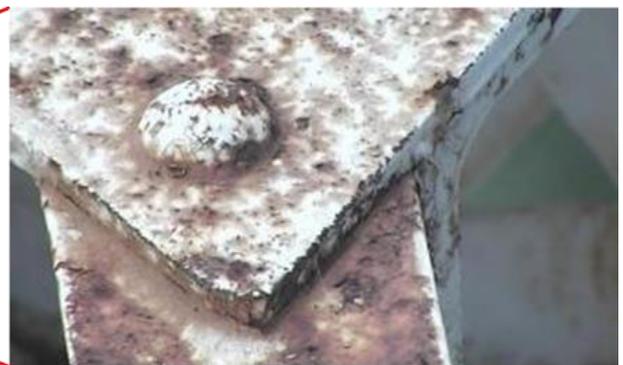
Figure 6. Images obtained by the *Robotic camera indicating crack scale for bridge inspection*.

Firstly, (I) Application to bridges with complex structures was confirmed. The “Robotic camera indicating crack scale for bridge inspection” was set up on the bridge surface, and the arm with the camera was expanded upwards. Then it can reach to close to the target member and images were taken by remote control. The camera size is enough small to insert into complex parts in the truss, and it can obtain the images as shown in Figure 6. Also, the function to zoom up the images as shown in Figure 6 (b) makes it possible to detect deformations of steel bridges. This function can be used to obtain the

In order to assess the deterioration of the corrosion, the following two types of information are important: as shown in Figure 6 (a) and Figure 8 (a), the wide-area information to understand the cause of the corrosion such as the deterioration of the coating, and as shown in Figure 6 (b) and Figure 8 (b), the narrow-area information to detect localized corrosion which can cause the downgrade of bridges. For instance, the deterioration of the coating is assessed by *the changing of the coating color, the occurring of the bumping in the local area and the occurring of the coating deterioration in wide-area by spot rusting* (Road Bureau 2019a) etc. Therefore, the wide-area information is required to understand the coatings conditions compared with the conditions around the target area. Regarding the localized corrosion, the obtained information will be used to judge whether to conduct additional measurements such as thickness reduction. Thus, the narrow-area information is required to detect the localized defects and understand those conditions.
